<CPT BOARD>

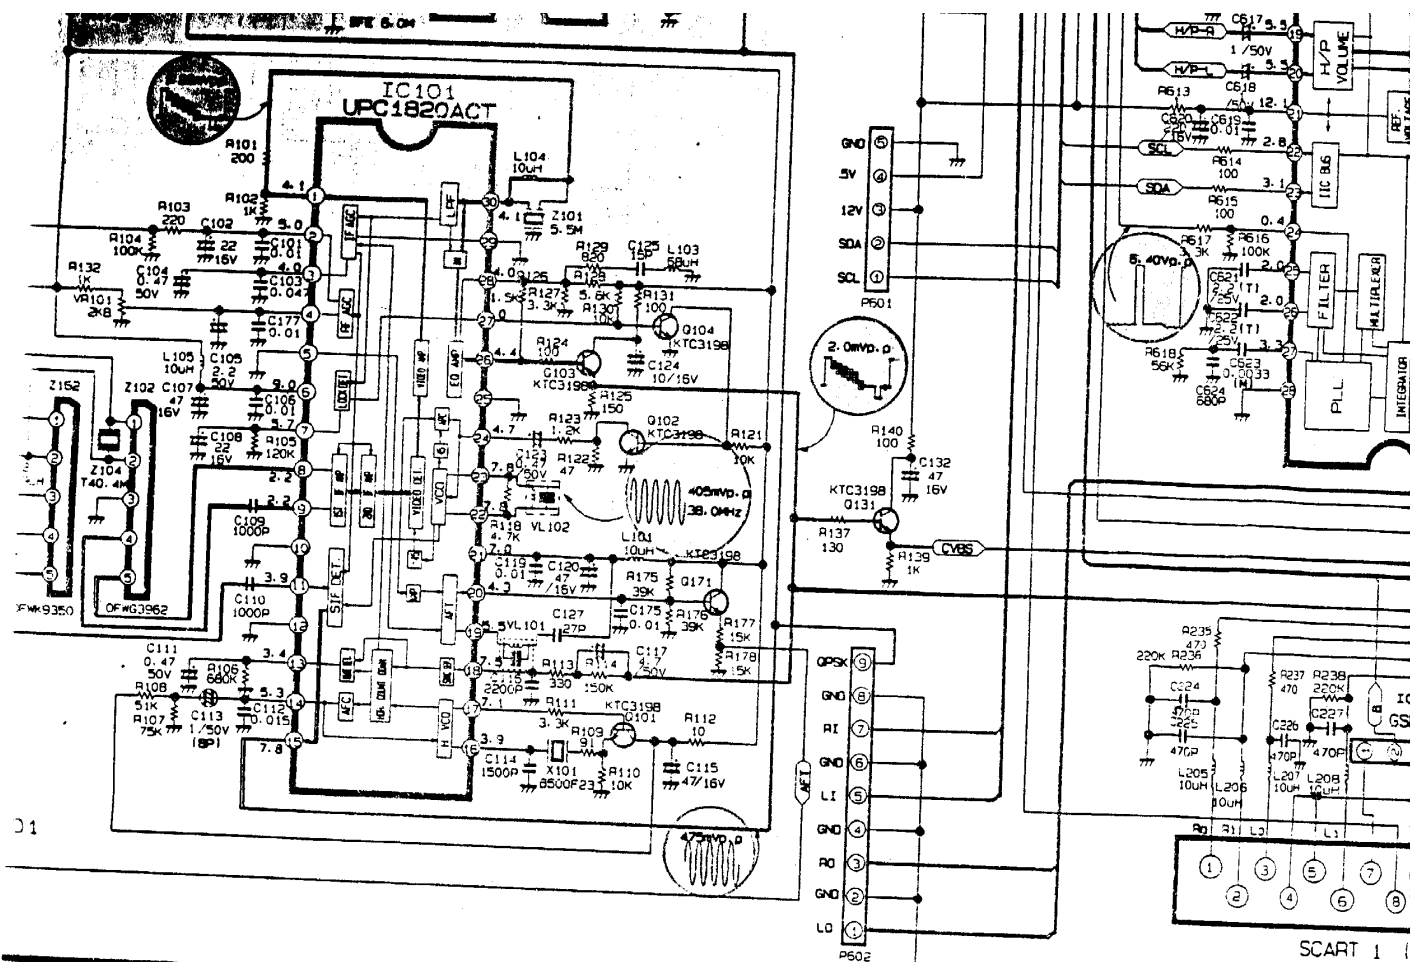
NO PICTURE/NO SOUND
(RASTER OK)

Check the 33V at Tuner

Check/Replace
FR703, D703, ZD704

Check the waveform at the emitter of Q103

Check/Adjust
VIF/SIF

Check the voltage at the
pin6 of IC101

Check/Replace
IC104

Check/Replace
IC101, Tuner

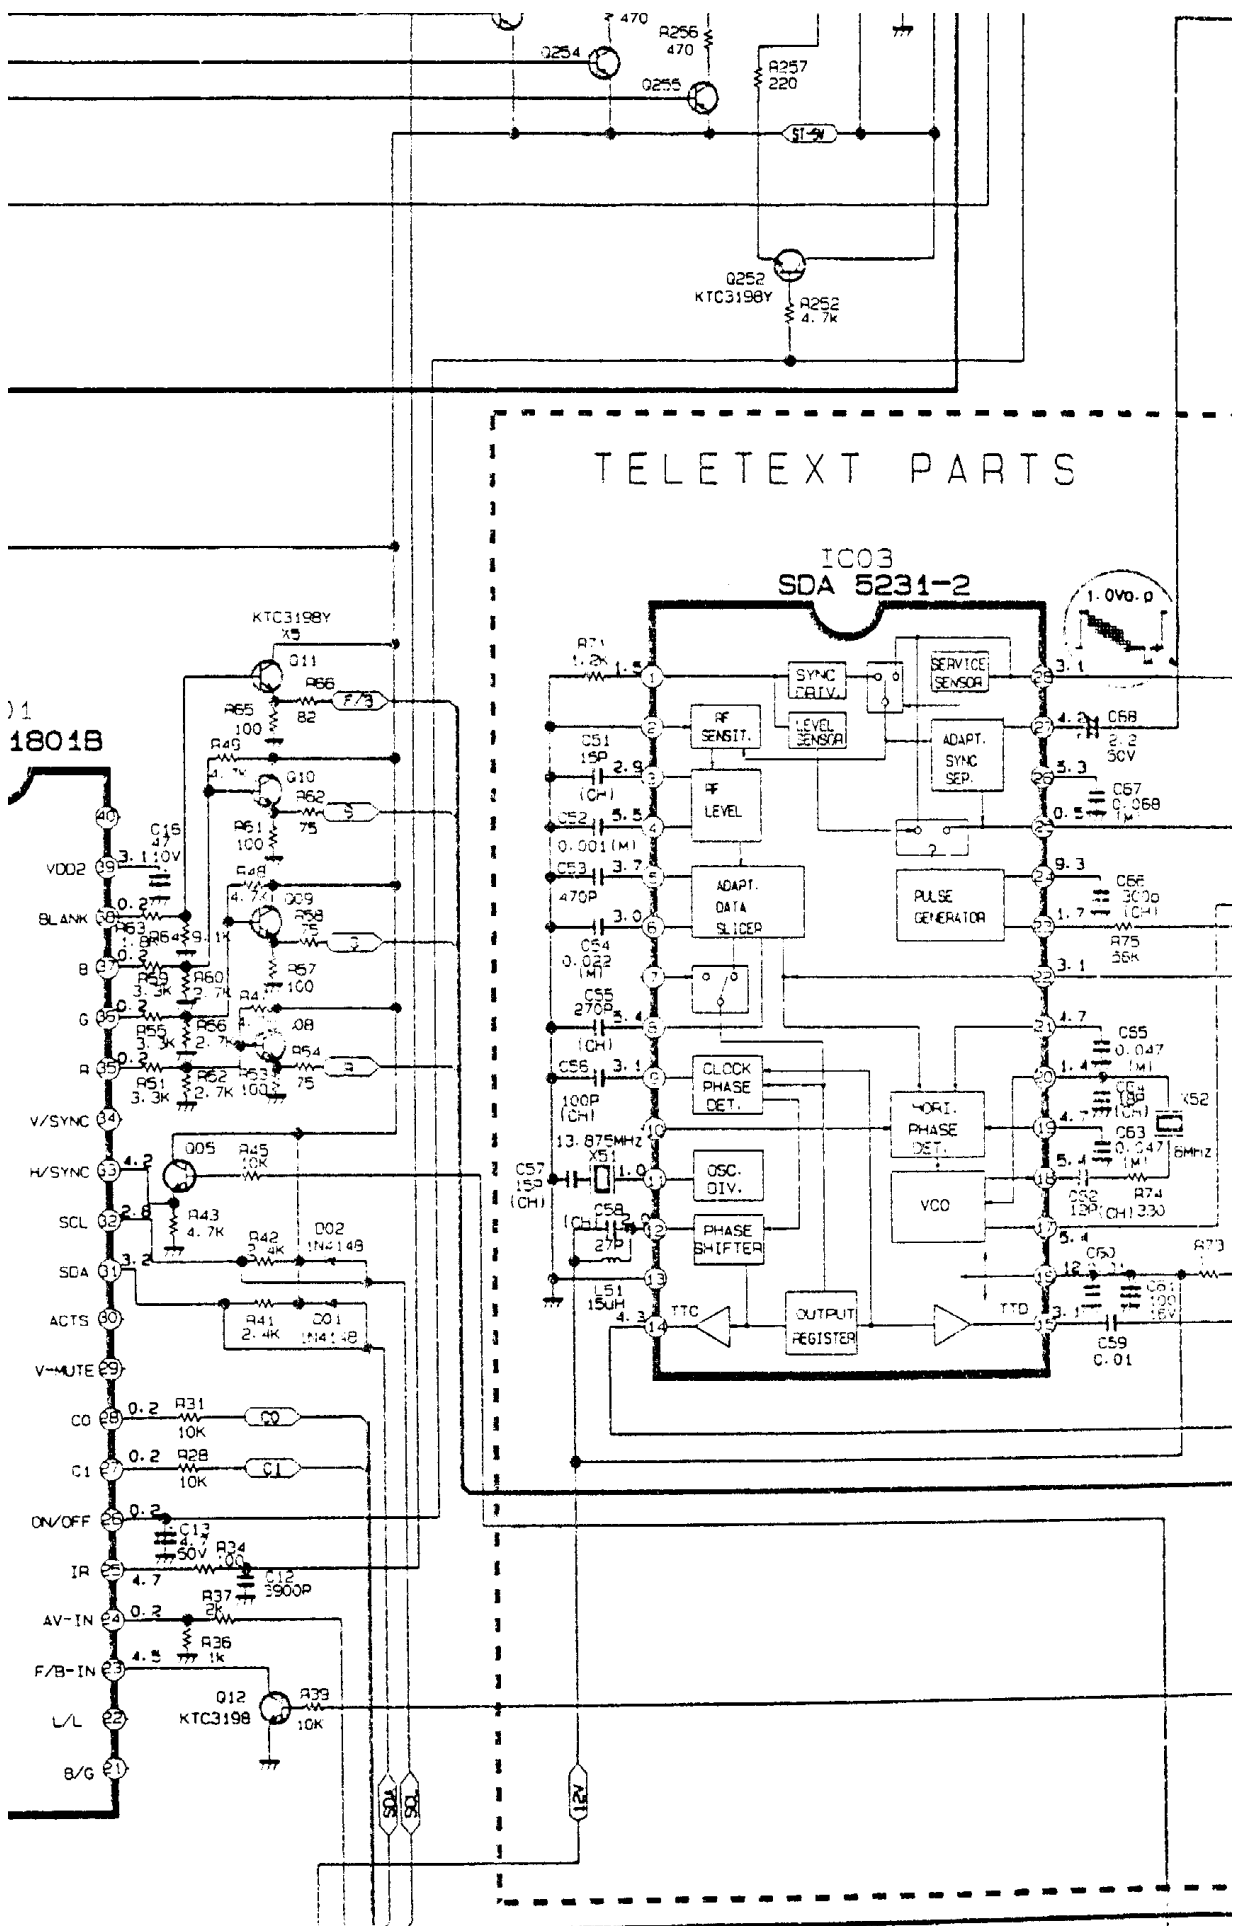
<CONTROL PARTS>

: CF-25C20 MODEL ONLY
